Subject: Phase 3 Removal Report, Rev. 1
35th Avenue Superfund Site
Technical Direction Document (TDD) No. 0001/OT-01-001
Contract No. EP-S4-15-01

PHASE 3 REMOVAL REPORT

35TH AVENUE SUPERFUND SITE BIRMINGHAM, JEFFERSON COUNTY, ALABAMA

Revision 1

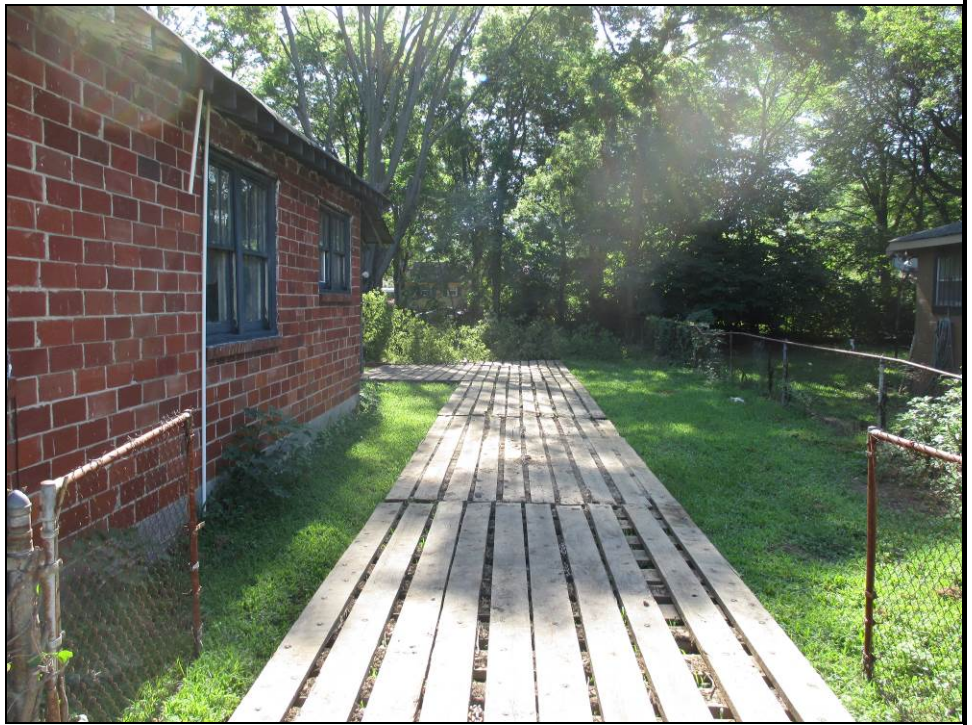
Official Photograph No. 3:
View of swamp mats in place on side yard in prep for excavation activities.

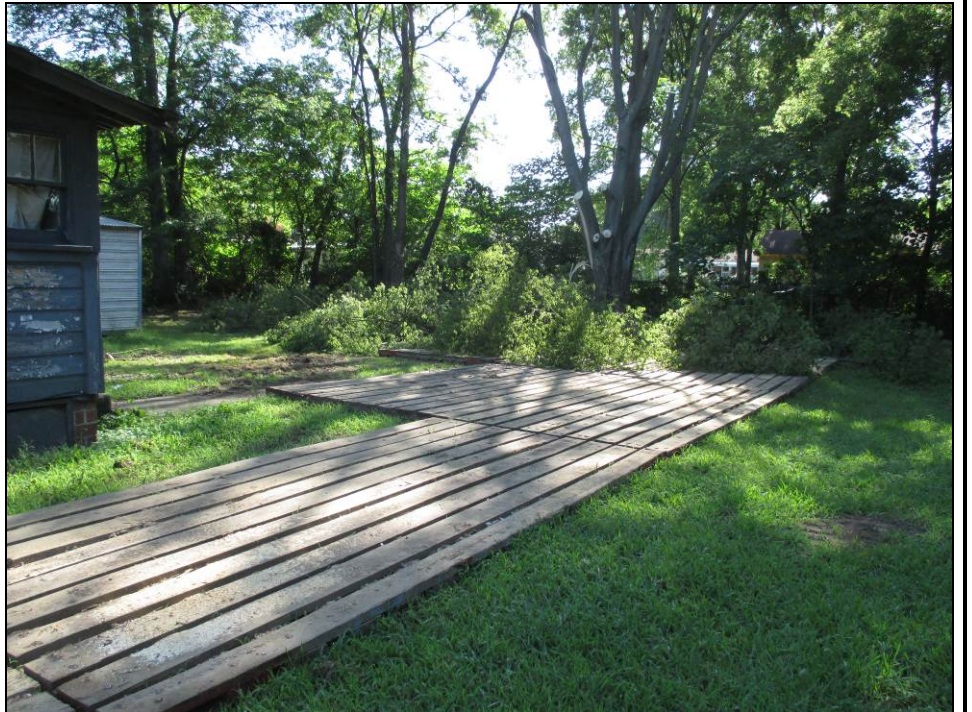
Official Photograph No. 4:
View of swamp mats in place in back yard in prep for excavation activities.

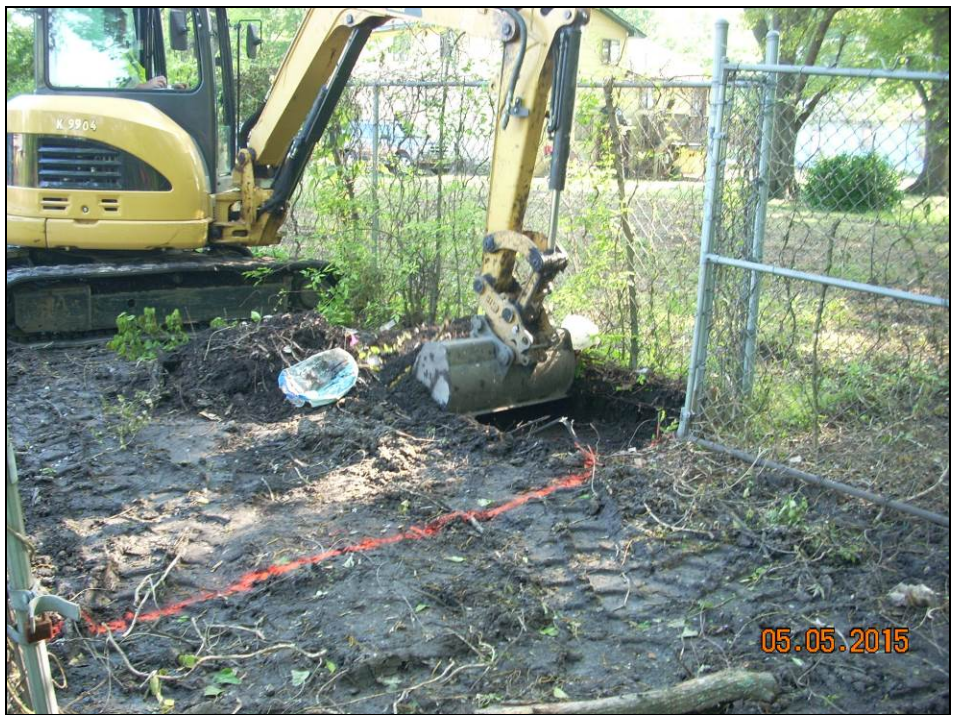
Official Photograph No. 3:
View of excavation activities in a side yard.

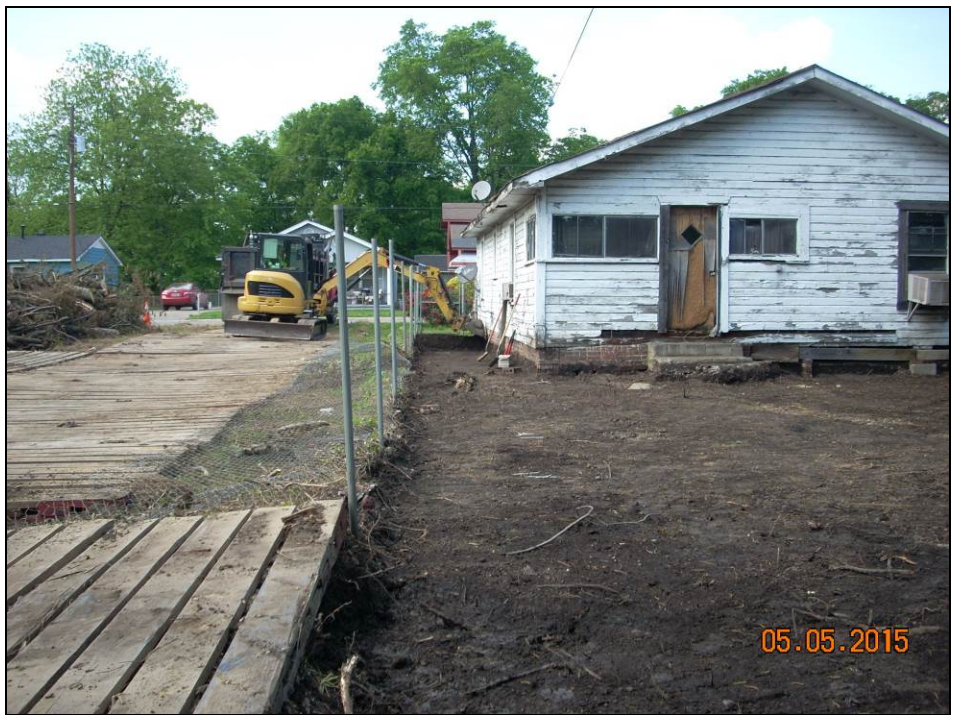
Official Photograph No. 3:
View of excavation in the back and the west side yards.

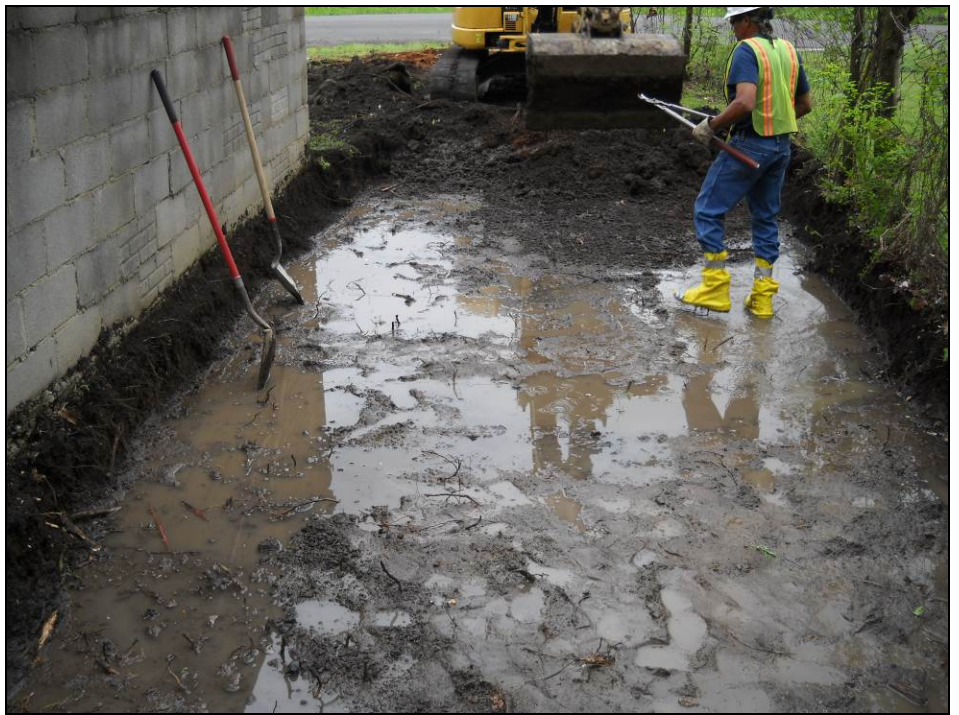
Official Photograph No. 3:
View of excavation activities in the back yard.

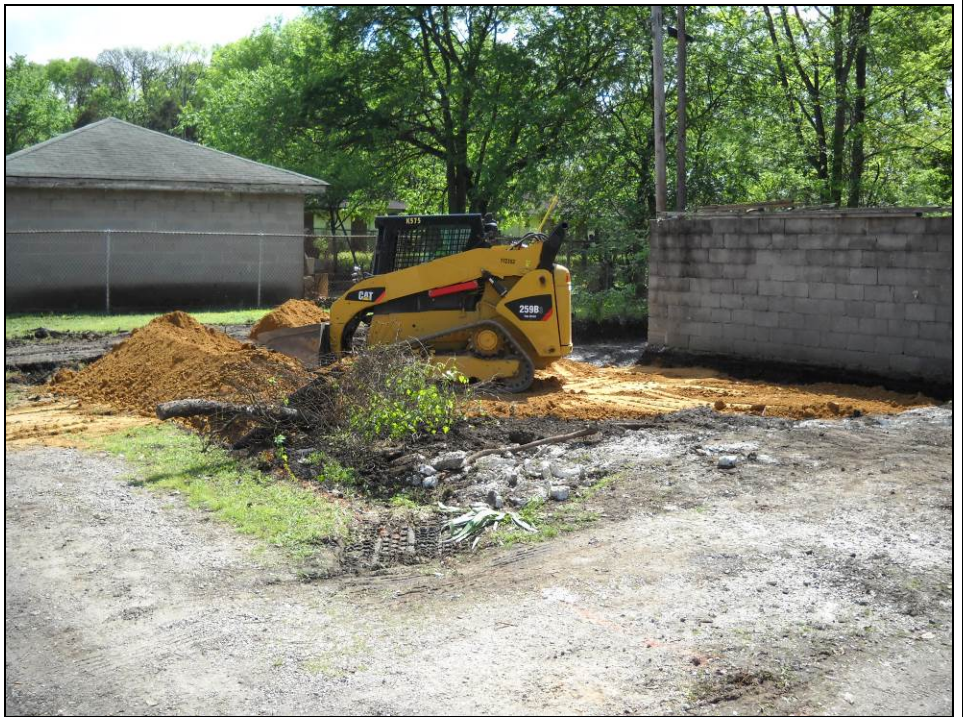
Official Photograph No. 5:
View of the backfill activities in the back yard.

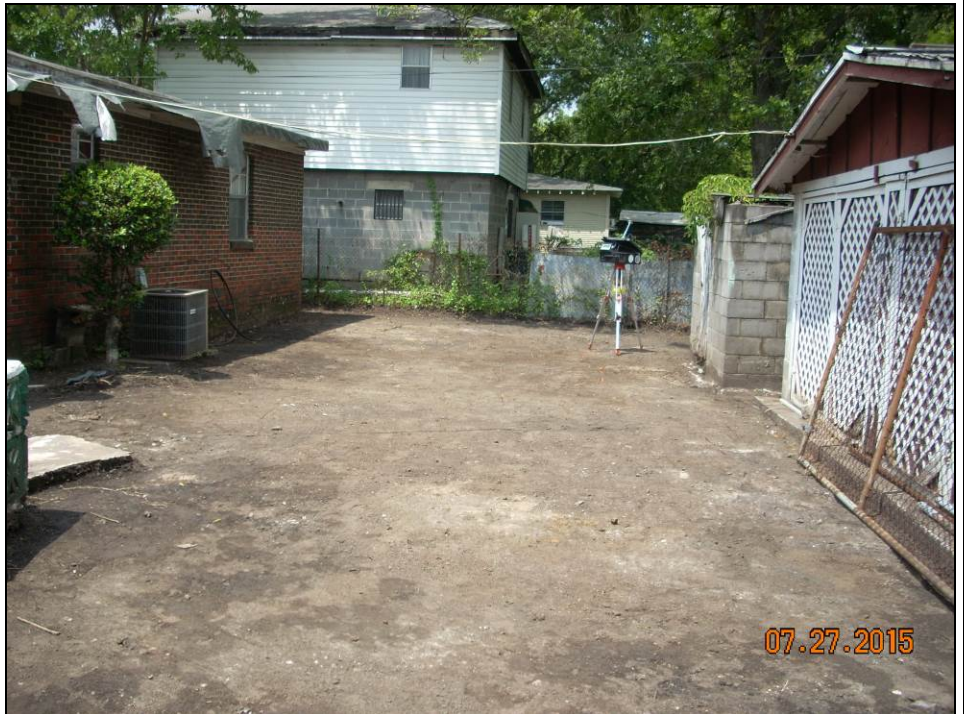
Official Photograph No. 2:
View of the excavation in the back yard facing west.

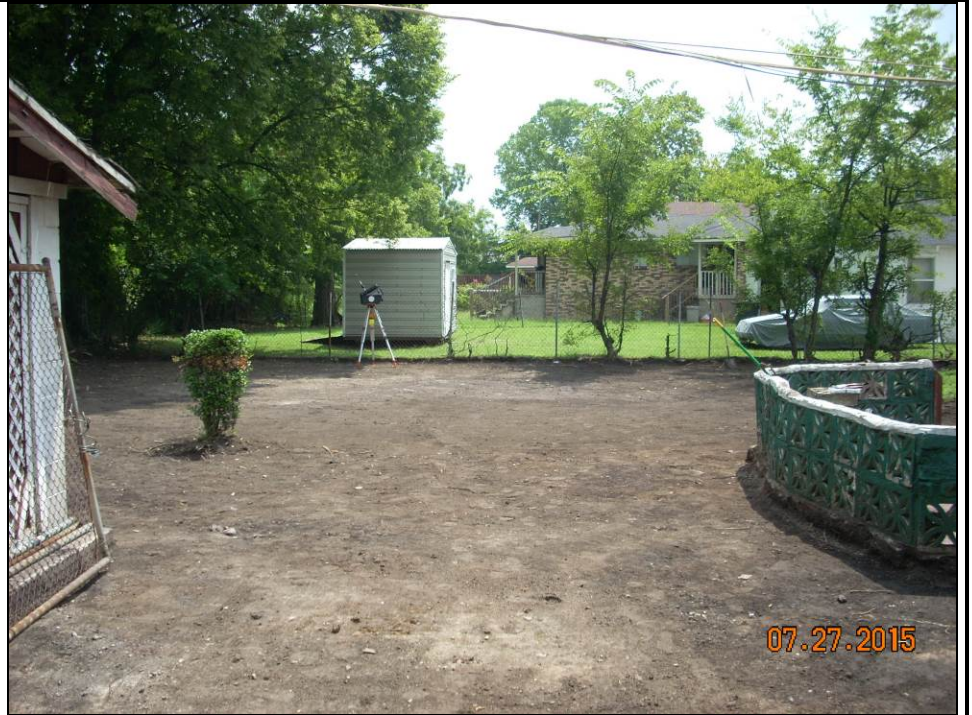
View of excavation in the back yard facing east towards bordering property CV0441.

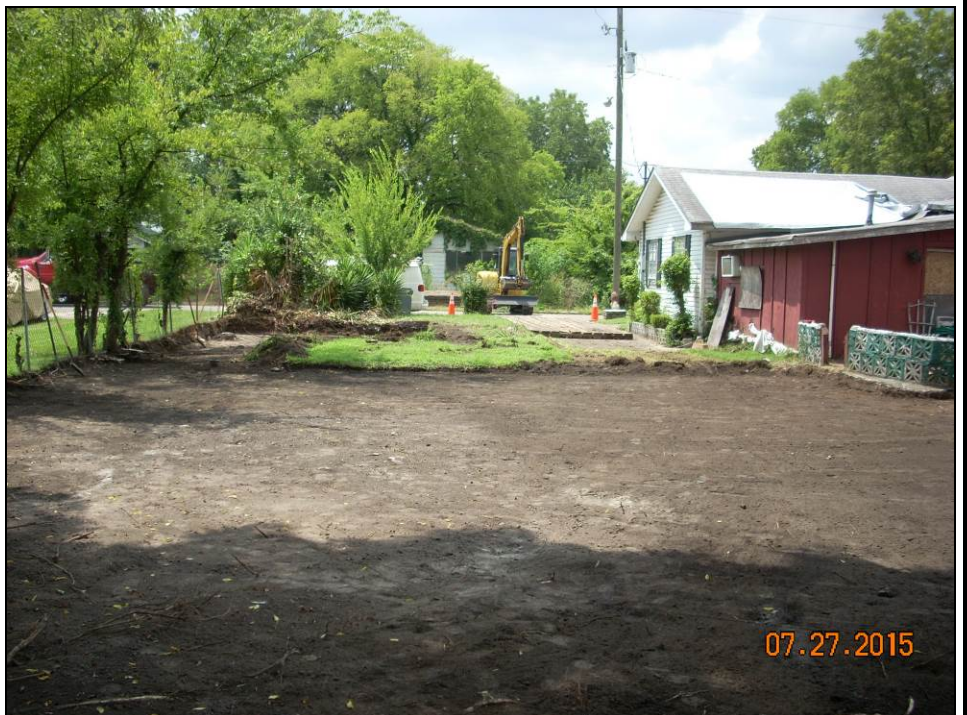
View of the excavation facing south.

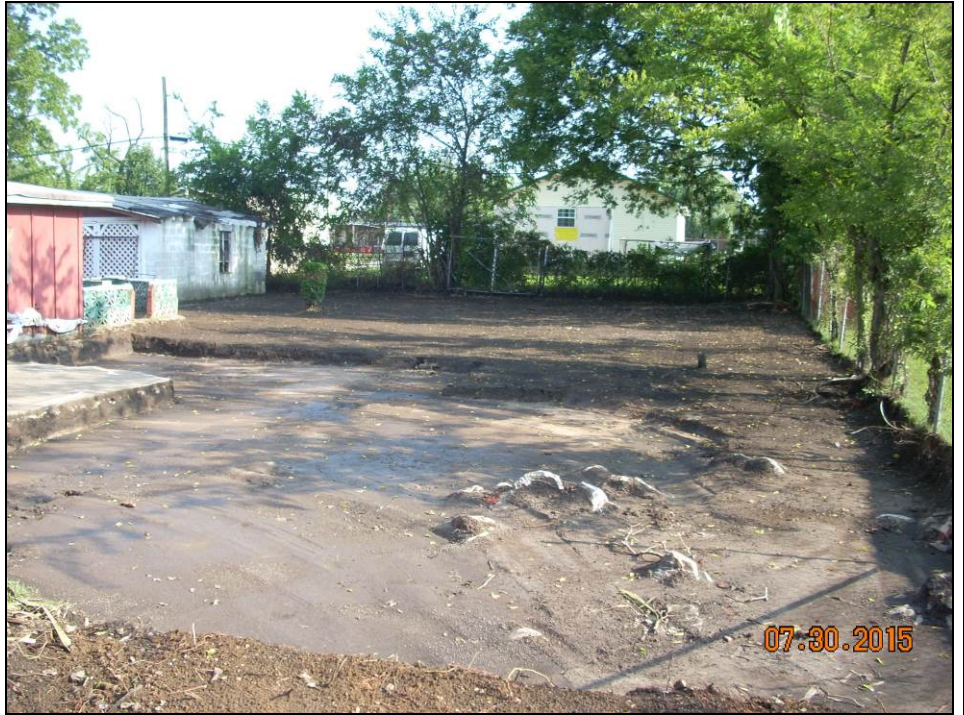
Official Photograph No. 5:
View of the excavation facing north.

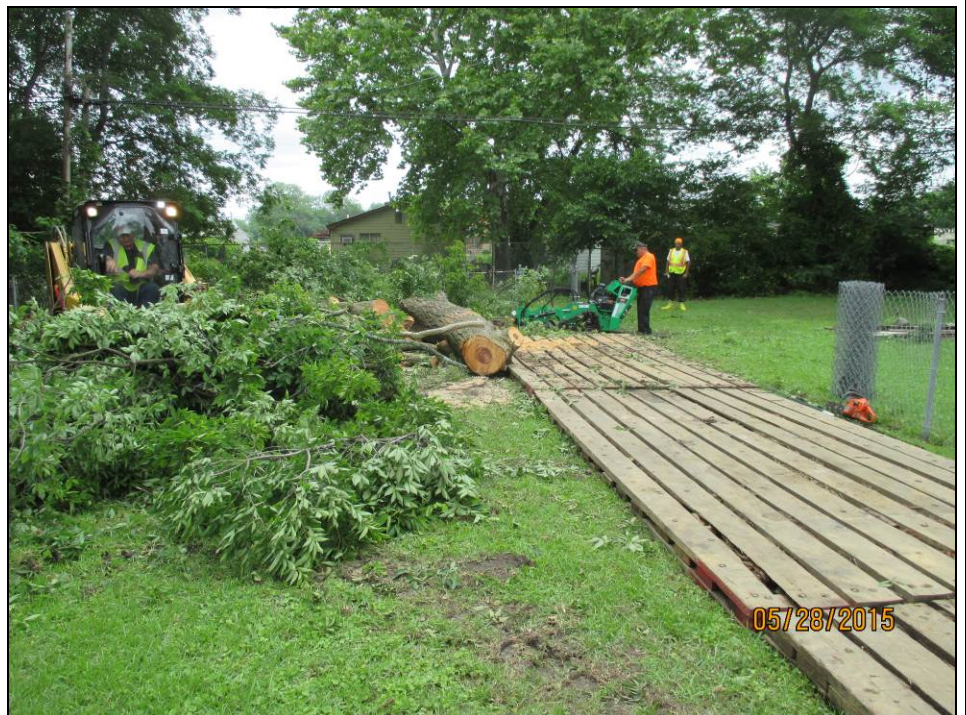
Official Photograph No. 2:
View of tree removal operations in the back yard.

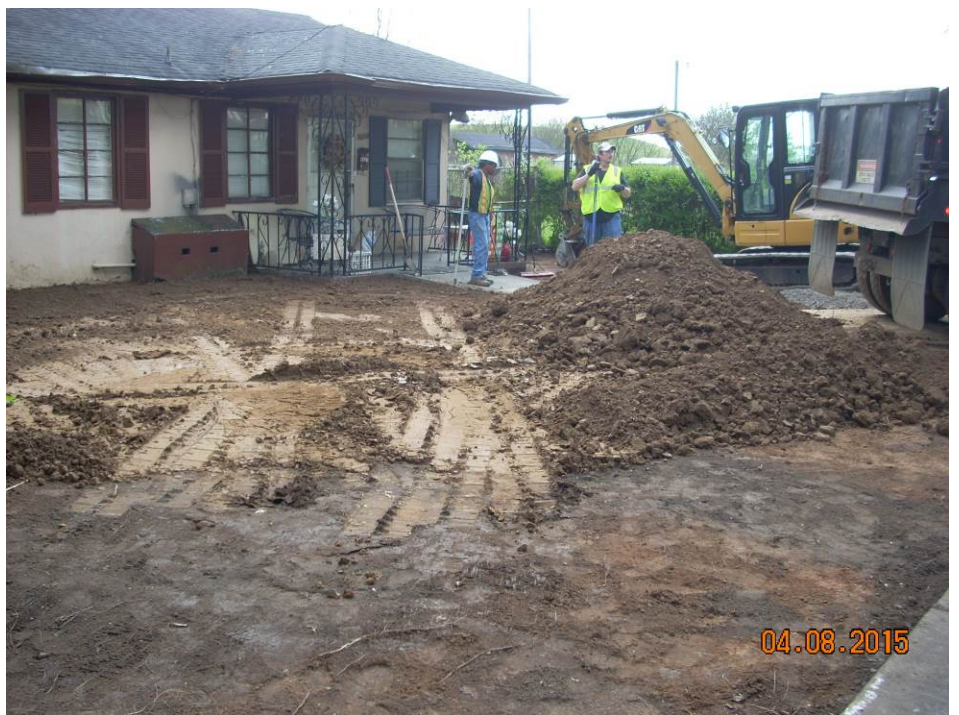
Official Photograph No. 3:
View of the backfill operations in the front yard.

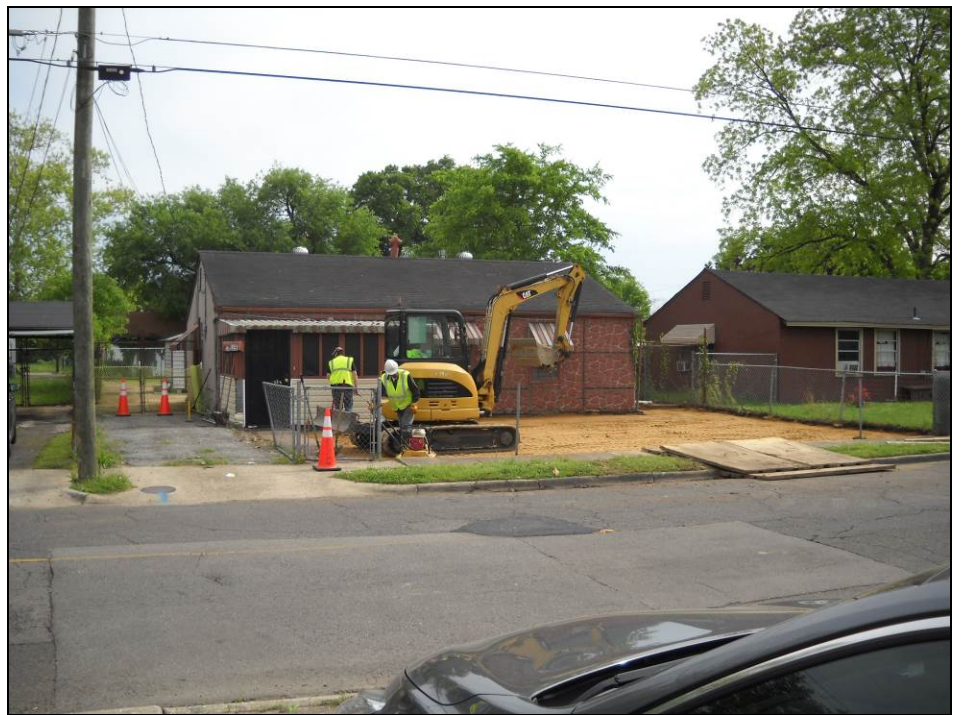
Official Photograph No. 9:
View of the backfill operations in the front yard south.

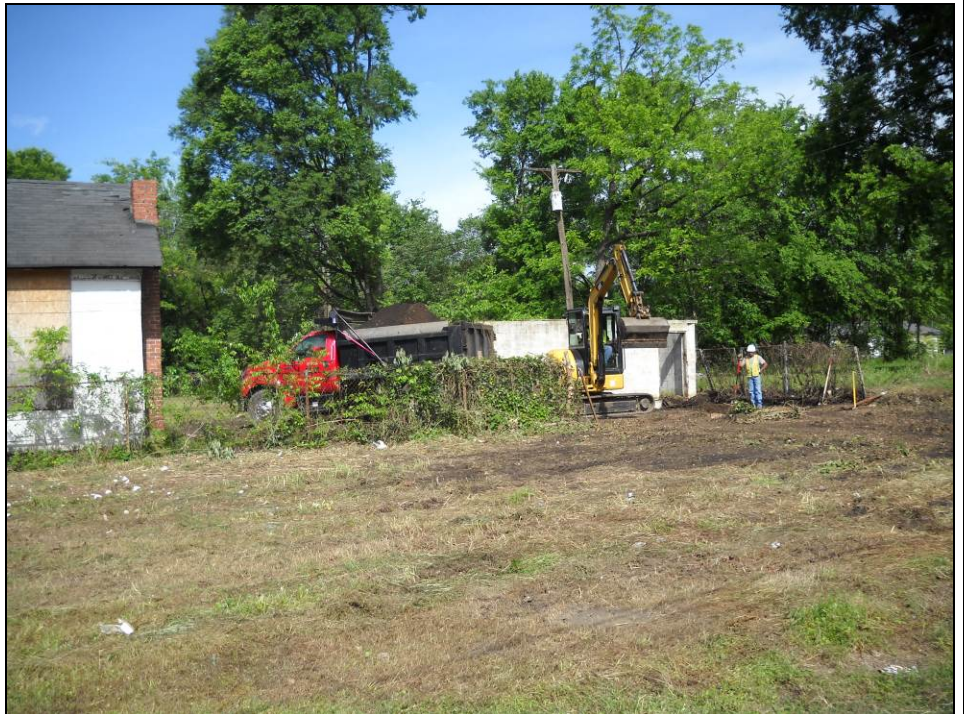
Official Photograph No. 2:
View of the excavation activities in the back yard.

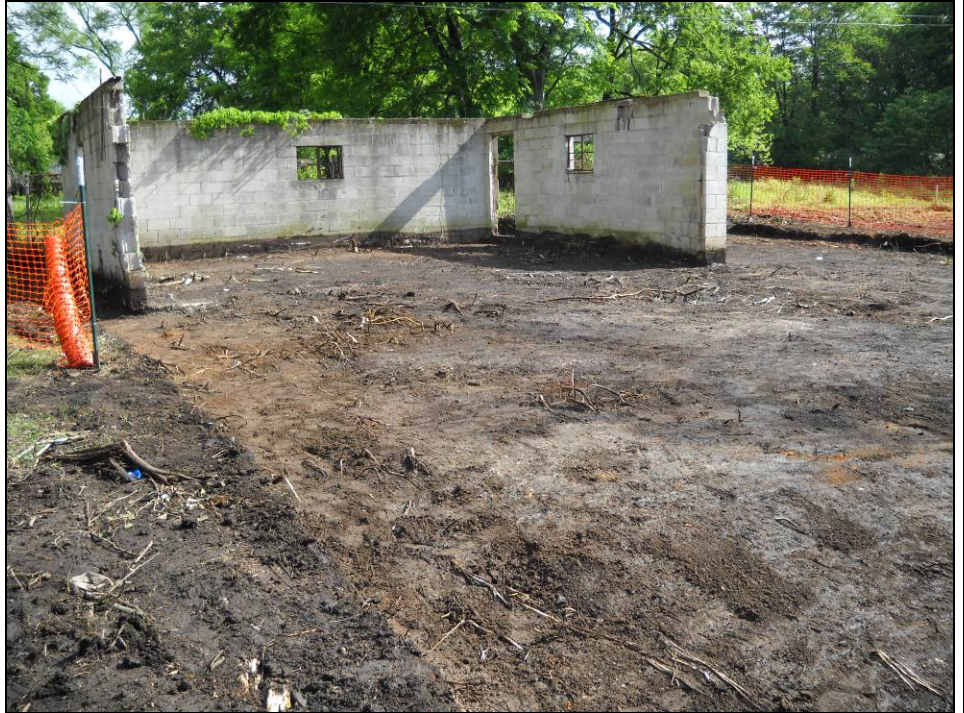
Official Photograph No. 3:
View of the excavation in the back yard.

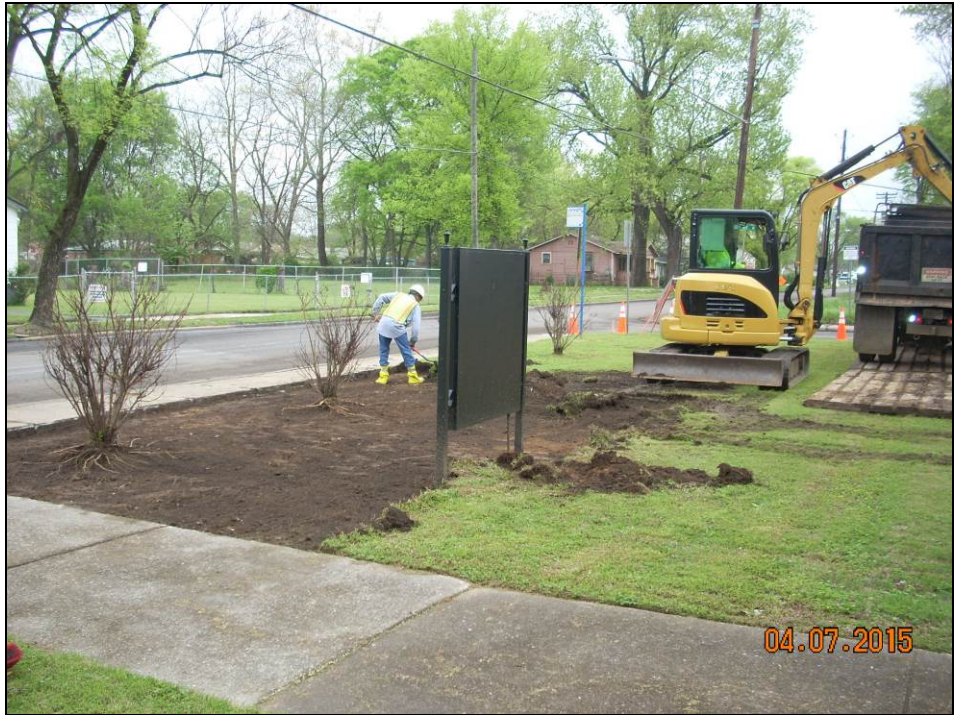
Official Photograph No. 5:
 View of the excavation activities facing northwest.

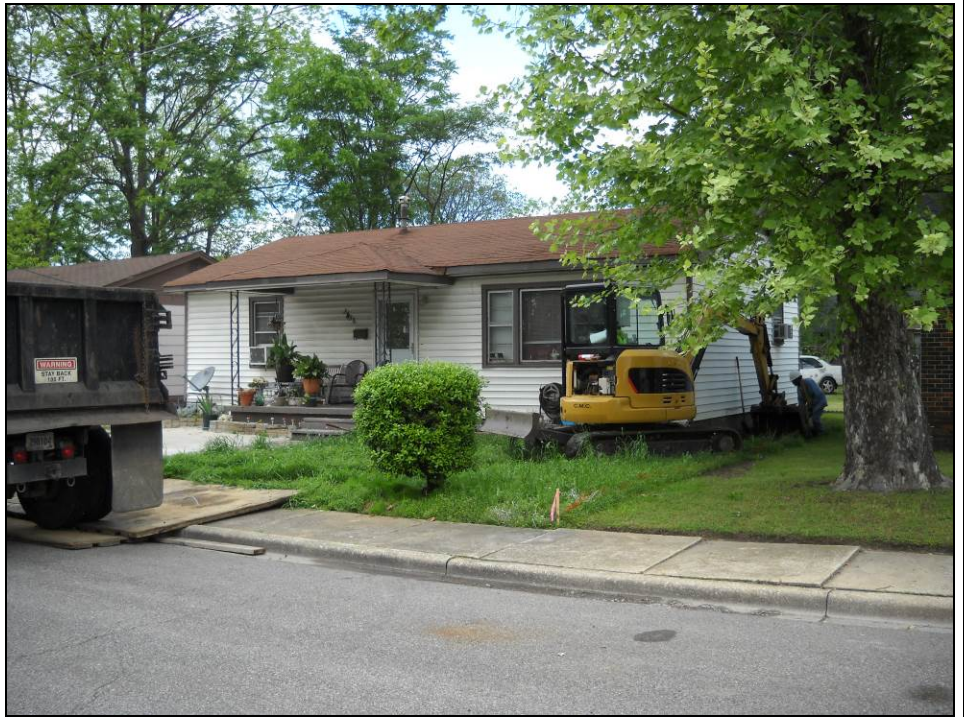
View of the beginning of excavation activities along the east side of the house facing north-northwest.

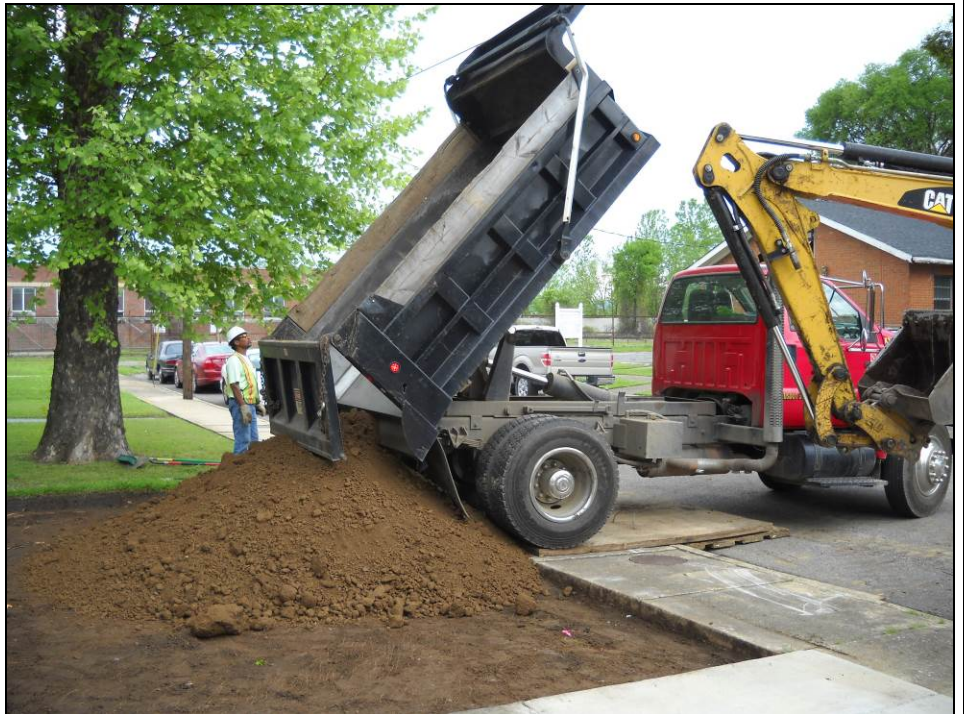
Official Photograph No. 4:
View of backfill activities in the front yard facing southeast.

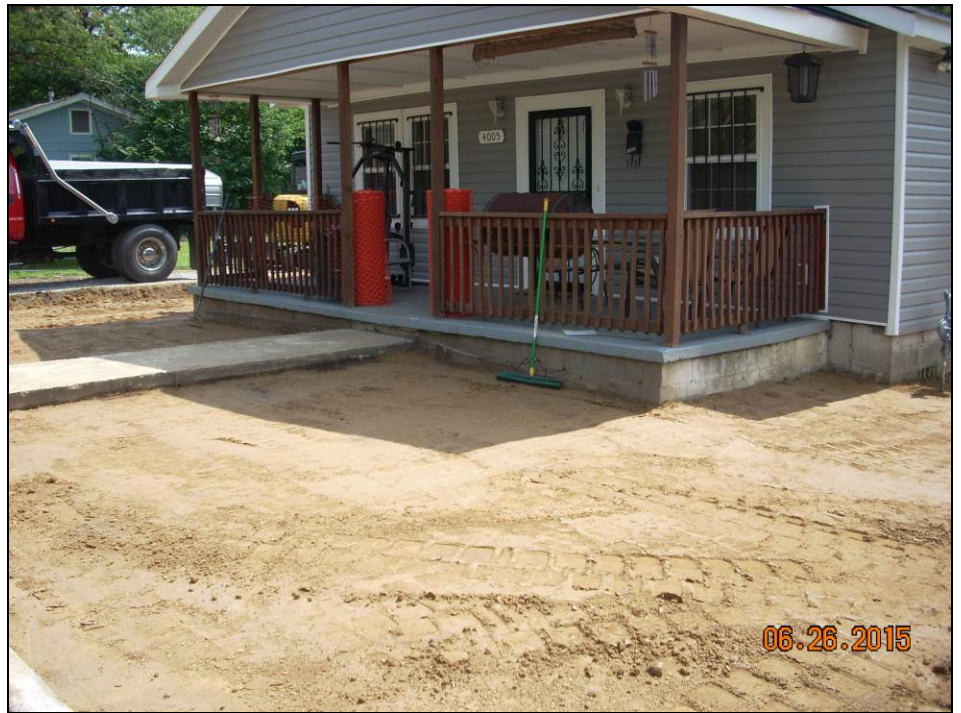
Official Photograph No. 5:
View of the backfill completed in the front yard facing northeast.

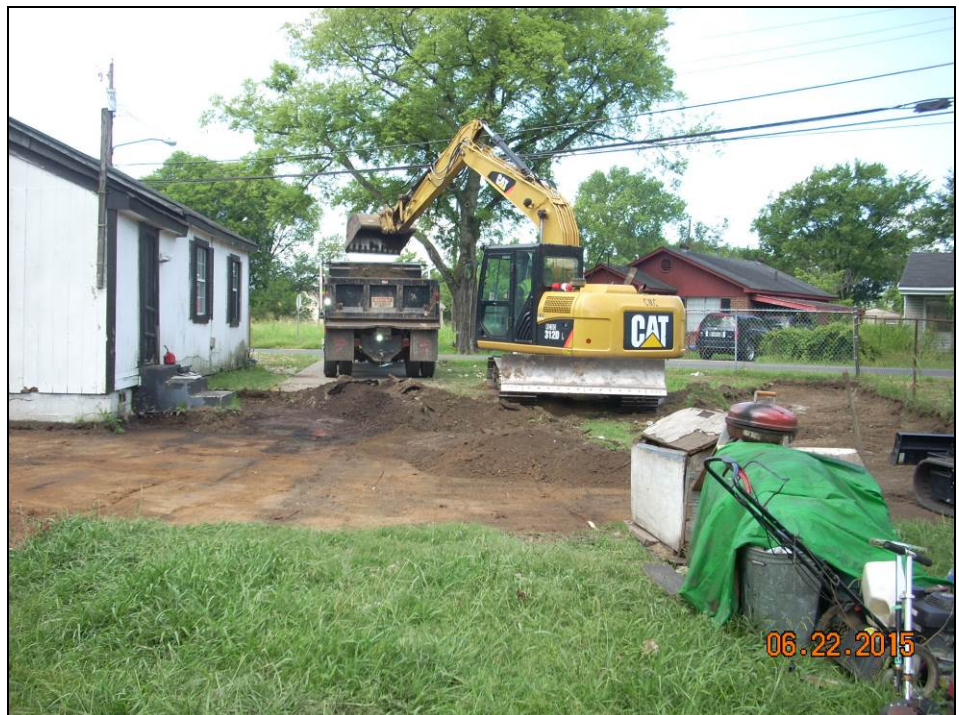
View of the excavation activities facing west.
